The fire resistance performance of two single-acting, single-leaf doorsets incorporating various items of hardware tested in accordance with BS EN 1634-1:2014

345074/A Issue 2

**Objective** To determine the fire resistance performance of two single-acting, single-leaf timber based doorsets incorporating various items of hardware, mounted within a low density rigid supporting construction in accordance with BS EN 1634-1: 2014.

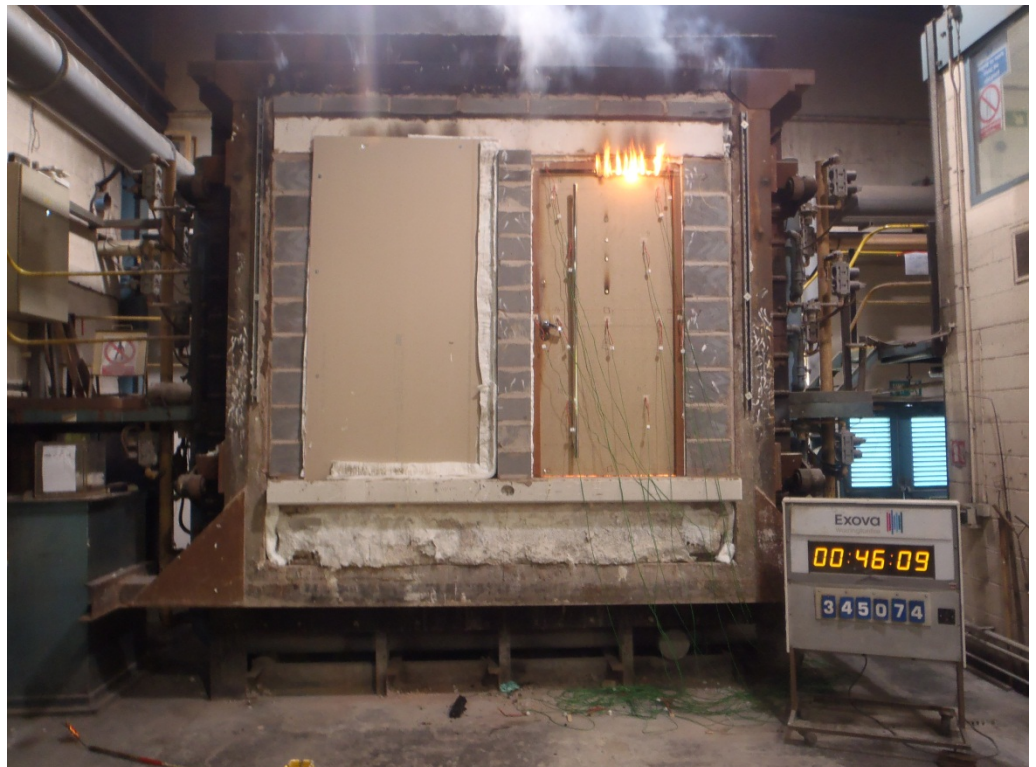
The unexposed face of the doorsets after 46 minutes of testing as sustained flaming formed at the head of Doorset B

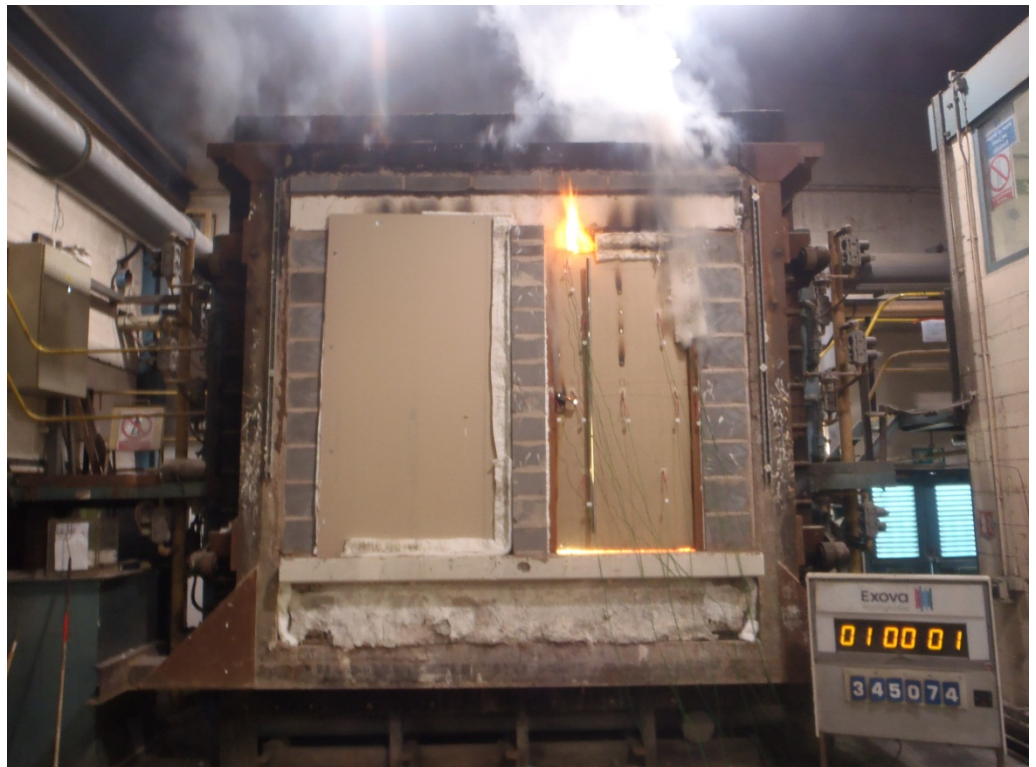
The unexposed  
face of the  
doorsets after 60  
minutes of testing  
after which time  
the test was  
discontinued

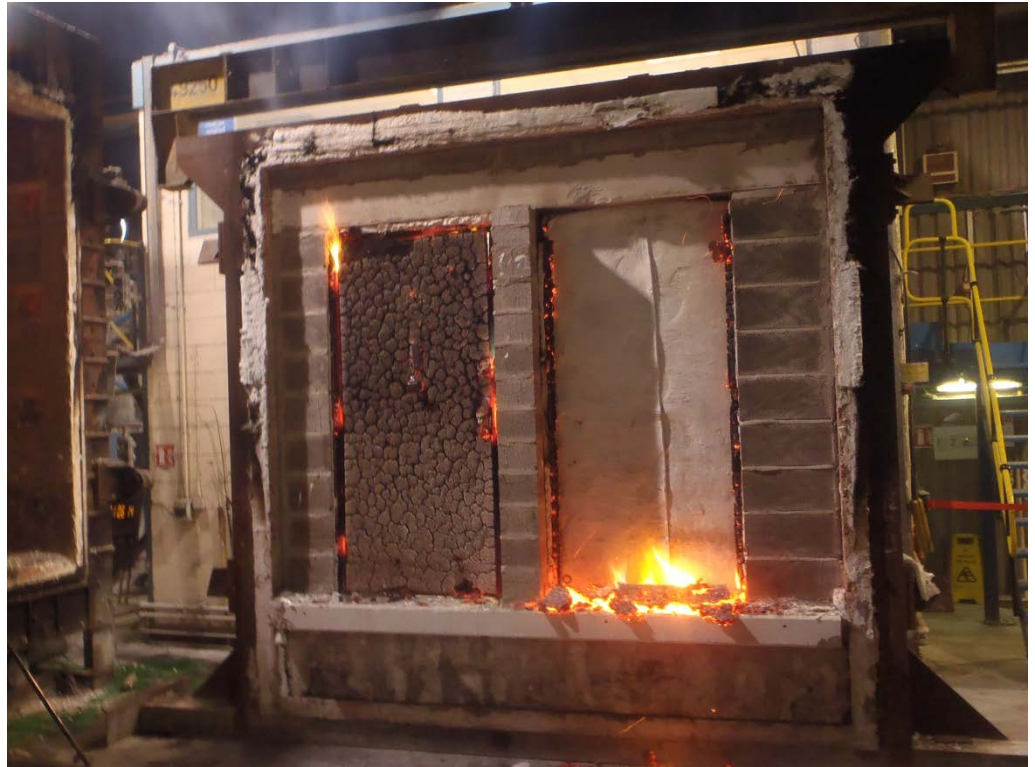
The exposed face  
of the test  
construction  
immediately after  
the test
